Understanding shoreline change on the Victorian coast: Mounts Bay, Great Ocean Road

Historic shoreline change on the Mounts Bay coast

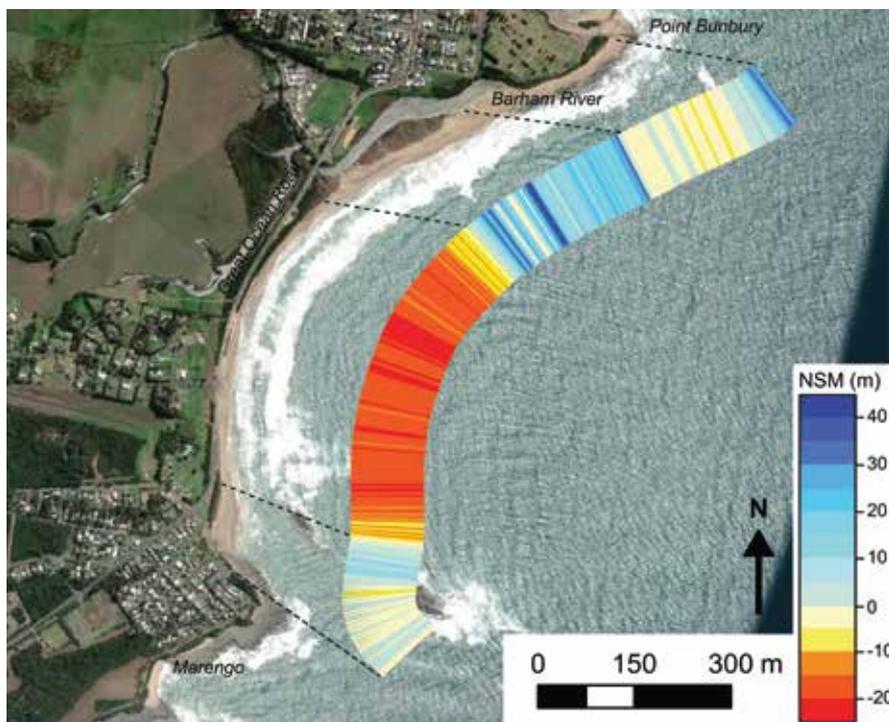
Shoreline change on the Mounts Bay coast showing net shoreline movement (NSM), calculated as the distance between the earliest (1968) and most recent (2019) shorelines. Negative values (yellow/orange/red) indicate landward retreat (erosion) and positive values (green/blue) indicate seaward advance.

Two areas of the Mounts Bay shoreline – the north-eastern extent of the study area adjacent to the Point Bunbury breakwater and the sand spit at the Barham River mouth – have grown overall since 1968. Shoreline advance at the sand spit has occurred only recently. Erosion between 1968 and 1986 led to the removal of pre-existing dunes on the sand spit. Re-establishment of dune plants on the spit since 2008 has formed a series of dune ridges measuring 5 m in height and up to 100 m in width. In 2019 the shoreline was located approximately 17 m seawards of its 1965 position.

Most of the remaining coastline here is eroded with occasional sections showing no significant net change in shoreline position. Since 1968, the shoreline between the Barham River mouth and Marengo has retreated by an average of ~3 m, although this extends to an average of ~8 m near the centre of the bay. Between 1968 and 1991 shoreline retreat occurred periodically, followed by periods of limited dune development and accretion. Erosion rates have

accelerated since 1991. The coast now consists of a steep erosion scarp, just 6 m from the road in places, compared to the wide (~20 m) foreshore reserve and dune present in 1968. Some of this sand is likely to have accumulated in the newly built sand spit dunes. Since 2017, beach renourishment and dune creation has been carried out on the most erosion-prone sectors of the coast, but shorelines are yet to show any substantial recovery.
