Understanding shoreline change on the Victorian coast: Cowes, South Gippsland

This fact sheet summarises the patterns of historic change for Observation Beach at Cowes, South Gippsland. This and other regional summaries are available at www.nesplclimate.com.au.

Historic shoreline change on the Cowes coast

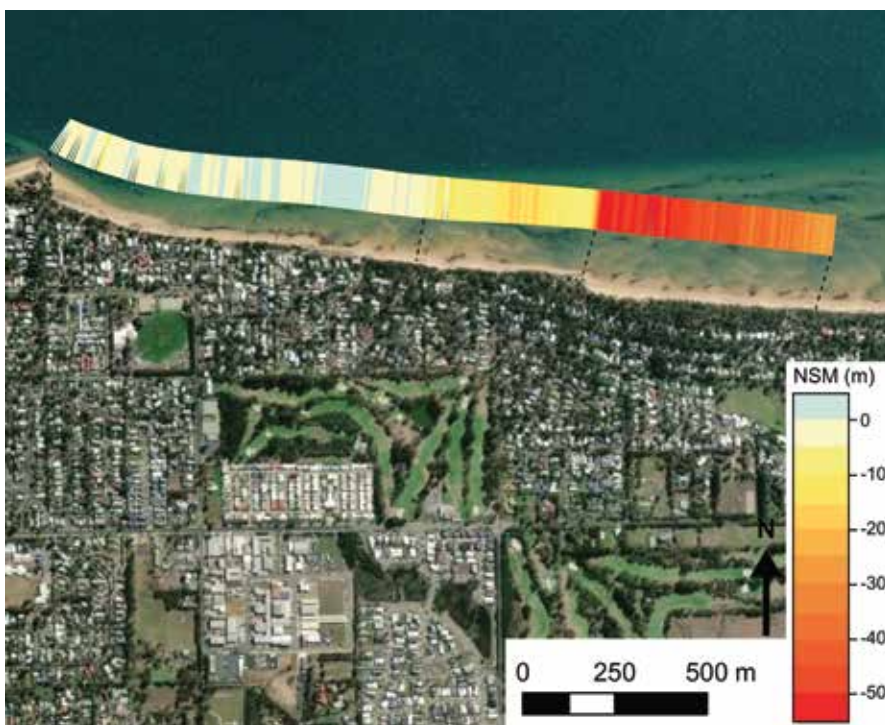
Shoreline change on the Cowes coast showing net shoreline movement (NSM), calculated as the distance between the earliest (1968) and most recent (2019) shorelines. Negative values (yellow/orange/red) indicate landward retreat (erosion) and positive values (green/blue) indicate seaward advance.

Through the western half of the study area – from Erehwon Point extending eastwards for ~1 km – the shoreline has been relatively stable, showing little to no shift (<5 m) in shoreline position since 1968. This stability is due to the early construction of shore protection structures which prevent shoreline retreat; in 1968 rock and timber walls adjacent to wooden groynes extended the length of this stable section of coast.

In contrast, the eastern half of the study area has shown progressive erosion since 1968. There are two sections of coast that show different patterns of change. The first extends from the 'stable' zone east for ~500 m and retreated by ~10 m between 1968 and 1979

until construction of rock walls prevented further erosion. The remainder of the study area remains unprotected. Here the shoreline has retreated by between 24 m (at the western extent of the study area) to 54 m. Most of the erosion occurred between 1979 and 2010. Erosion has slowed here since 2010 but the shoreline remains vulnerable to further erosive events.
