# Understanding shoreline change on the Victorian coast: Seaspray, East Gippsland

This fact sheet summarises the patterns of historic change for Seaspray Beach, East Gippsland. This and other regional summaries are available at [www.nespclimate.com.au](http://www.nespclimate.com.au).

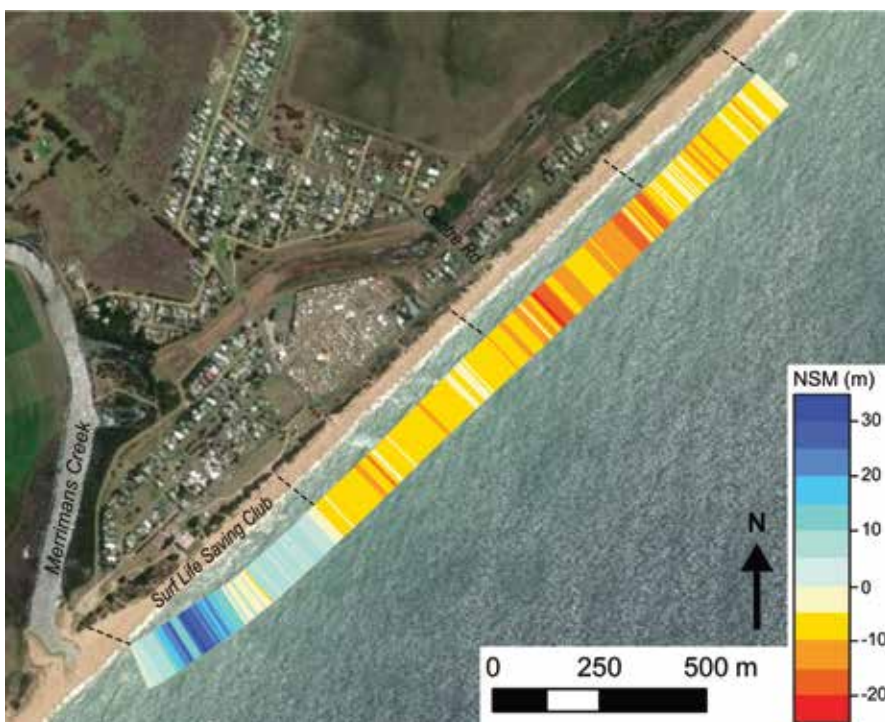
Shoreline change on the Seaspray coast showing net shoreline movement (NSM), calculated as the distance between the earliest (1965) and most recent (2019) shorelines. Negative values (yellow/orange/red) indicate landward retreat (erosion) and positive values (green/blue) indicate seaward advance.

One area of the shoreline – the western extent of the study area between Merrimans Creek and the Surf Life Saving Club – has grown overall since 1965. This shoreline advance has occurred episodically, related to the movement of the Merrimans Creek mouth and the establishment of dune plants on the beach (including when vegetation was deliberately planted). While this section of coast has retreated slightly (~10 m) since 2004, in 2019 the shoreline was still located approximately 20 m seawards of its 1965 position. The dunes now consist of a wide (~50 m) series of dune ridges measuring up to 6 m in height, compared to the low (~4 m) and narrow (~30 m) dunes present in 1965.

East of the surf club the protective dunes consist of a single narrow (~20 m) ridge. Here the study area has large eroded sections along with occasional sections showing no significant net change in shoreline position. Since 1965 the shoreline has retreated by an average of ~10 m, although this extends up to 22 m near the Centre Road intersection.
